# Manhole Inspection Summary

Manhole # S37WW\_021MH

Insp Date: 1/10/07 12:39 PM

**Location** Address: **3052 MATHEWS ST**

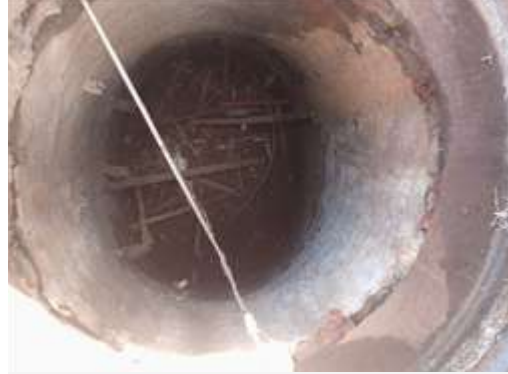
Top View

Frame leaks. Adjustment deterioration and infiltration. Barrel infiltration. Corroded and missing steps. Channel

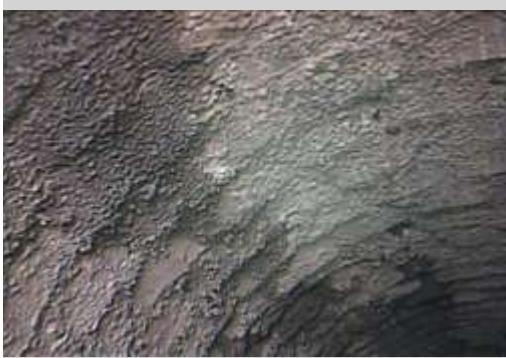
Defect

Adjustment, Corbel and Barrel infiltration.

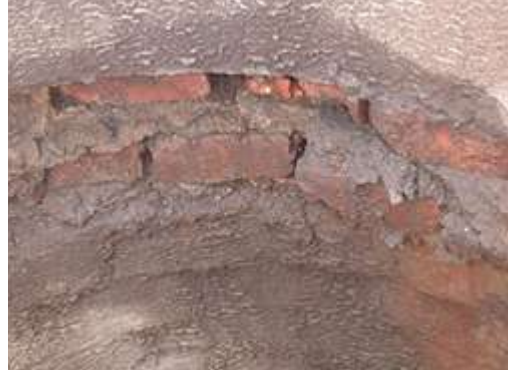
Defect

Frame leaks. Adjustment deterioration and infiltration.

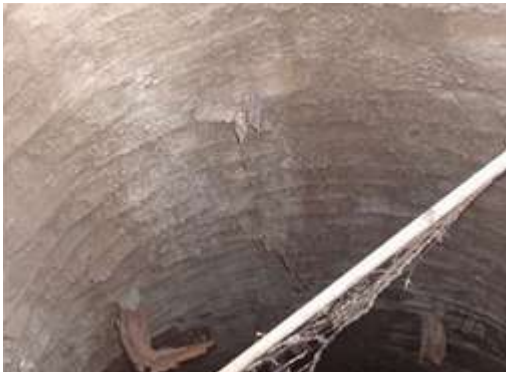
Defect

Corroded and missing steps. Barrel infiltration.

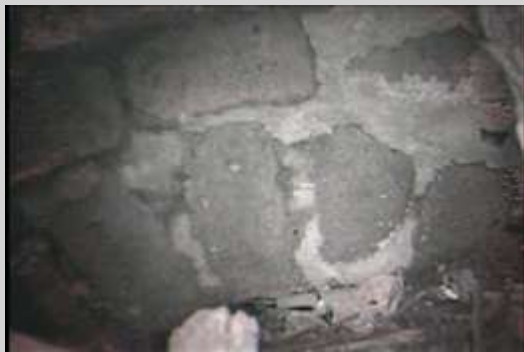
8 in. Circular Gravity Sewer  
Pipe Out @ 12 O'Clock

Deposits: ☐ None ☒ **Mud** ☐ Sludge ☒ **Debris** ☐ Grease

Silt Depth: **8** (in.) Deposits Extent: **Light**
